May 24, 2005
Edward Rys Jr.
Lenovers Pro Bldg. Products
13420 Wayne rd
Livonia Mich. 48150

This letter is a report on the test of a QS Pro deck guardrail system we conducted on April 28, 2005 at the Brooks Forest Products Center, Department of Wood Science and Forest Products, Virginia tech, Blacksburg, VA.

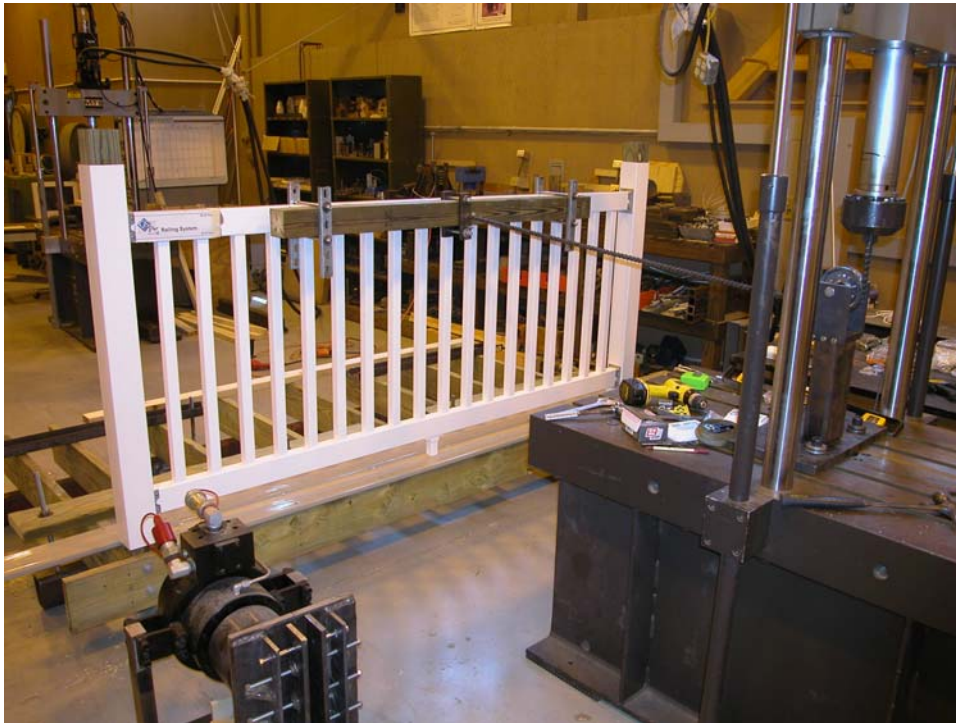
Photo 1: Test set-up showing rail system and test machine.

The test involved applying a horizontal force to the railing, 42 inches above the deck surface (43.5 in. above the top of the joists), and measuring the load and deflection to failure. The procedures in AC-174 were used. The load was applied at the quarter points on the top rail. A 50,000 pound capacity MTS servo-hydraulic testing machine with computer data acquisition was used to apply the load. The test arrangement is shown on Photo 1. All wood elements were ACQ treated southern yellow pine in the wet moisture condition. All bolts were ½ in. diameter and washers were used under the head and nut. All screws for constructing the deck were 3 in. long #10 stainless steel (SS).

The AC-174 requirements were followed and a horizontal load was applied at 42 in. above the deck surface. The load was applied at the quarter points on the top rail, 2 ft away from each post. The load was applied at rate of 1/2" in. of ram movement per minute up to failure. A roller chain and a spreader bar were used to apply the load from the testing machine to the specimen.

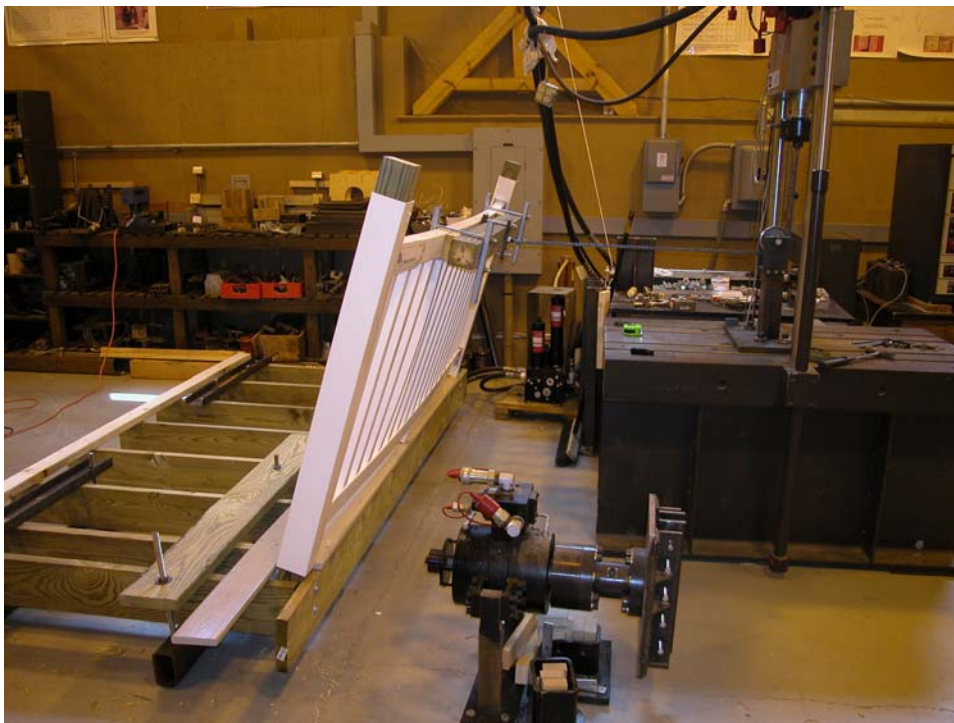
Photo 2: Test in progress showing the deflection of the rail and post just before failure.

The posts were connected to a 2x8 wood joists deck system. The system was rigidly fastened to the laboratory floor (Photo 2). Each 4x4 was attached to the joist with one Simpson HD2A hanger located 1.5 in. below the top of the joist and one lower bolt through the band joist and the post located 2- ½ in. above the bottom of the band joist. The Simpson HD2A connector uses two bolts through the sides of the joist and one bolt through the face of the hanger, post and the band joist. The posts were "inside" the band joist as shown in Photo 2. Three SS screws were used to connect the band to each joist.

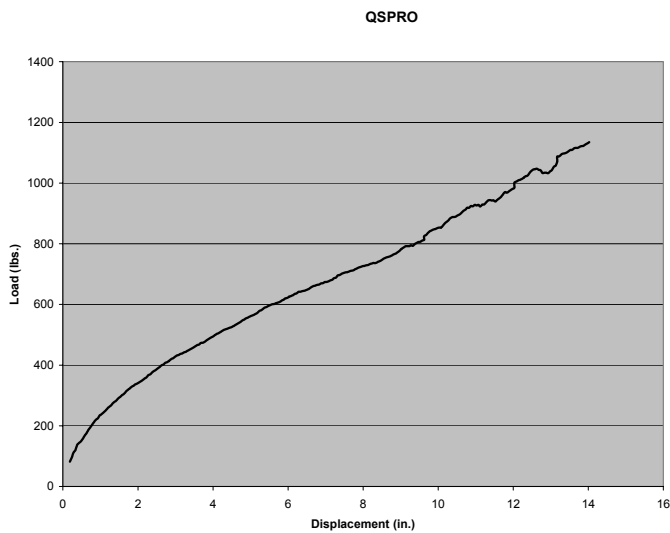
Figure 1 Load-displacement curve of QS Pro rail test

Figure 1 shows the load vs. deformation curve. The specimen failed at a load of 1153 pounds or 576 pounds per post. The failure mode was snapping of one of the posts at the deck surface. After the failure of the post, the QS Pro top rail immediately returned to its initial shape and did not appear to be damaged by the test indicating that the top rail was in the elastic range of its response. The cast zinc connector also appeared to be undamaged after the test. The AC-174 requirement of 500 lbs per post was met and exceeded by the QS Pro rail system.
